Inspection Report

Report Date	5/6/2015	
Company	Northeast Resource Group Inc.	Customer
Address	95 Court Street Plymouth, MA 02360	Site Address
Thermographer	Mark Parquette	Contact Person

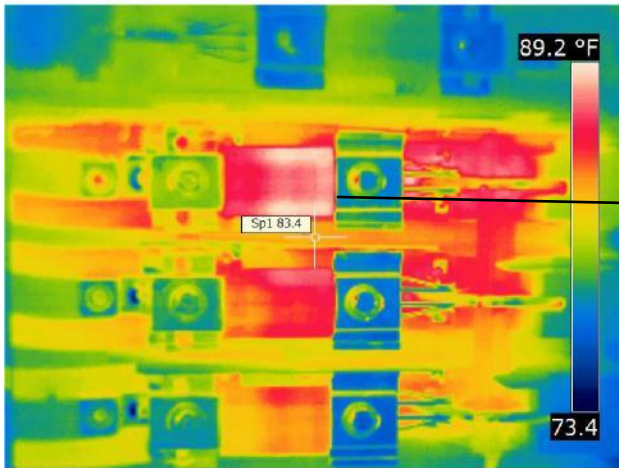
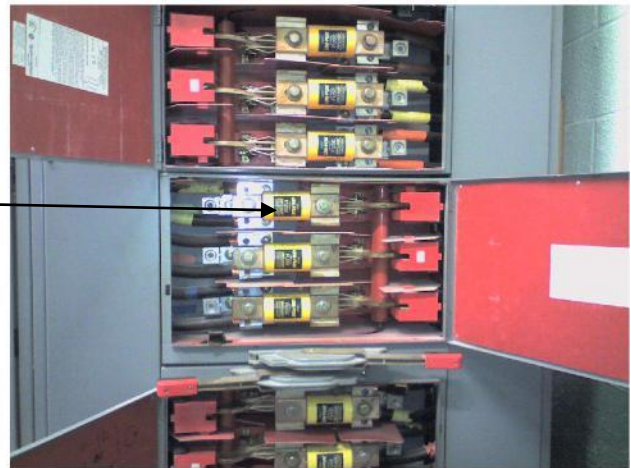
Camera Model	FLIR T360_ Western
Image Date	5/2/2013 8:53:05 AM
Image Name	IR_0069.jpg
Emissivity	0.95
Reflected apparent temperature	68.0 °F
Object Distance	3.3 ft

Location: MAIN ELECTRICAL ROOM
 Target: MAIN GEAR - SECTION 4 -1LC SWITCH

Comment: Temperature delta between fuses as well as load and line side of L1 indicates a possible issue with the fuse holder and/or connection. This switch should be shut down and completely inspected and corrected as needed during the shutdown.
